Excavation Report Hamnholmarna (MVID#1516)

Maritime Archaeological Society of Finland report against Finnish Heritage Agency's research permit **MV/01110/2024** regarding the Kemiönsaari, Hamnholmarna (MVID#1516) intrusive test excavation.

Hamnholmarna (MVID#1516) Excavation Report

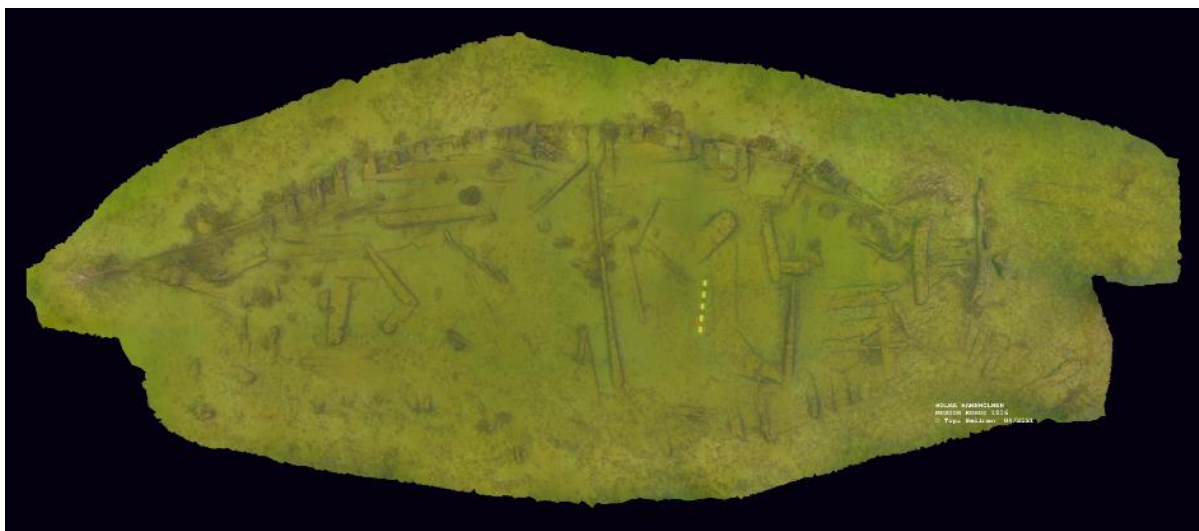
Image 3. Hamnholmarna wreck from the bird's eye view prior to intrusive study.

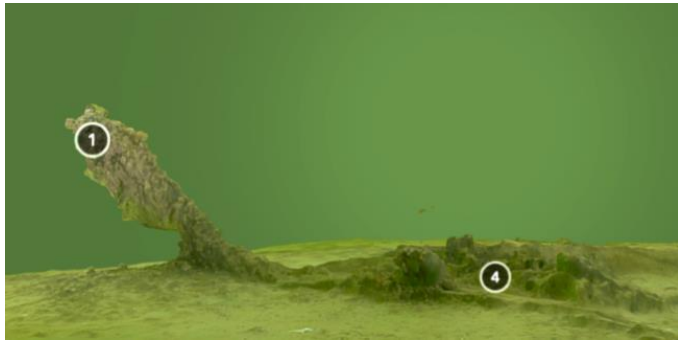
Image 4. View of the probable stern post from which the C14 sample was taken. In 2024 this stern post has sadly now collapsed into the wreck. Notice how submerged the wreck is into the silt.

Status of the wreck – From its modelling in 2019 to 2024 the wreck seemed to have changed very little, except sadly that the probable stern post had collapsed into the wreck, whether from decay or being caught by something (see model below). If it was snared by something the fact that the wreck is largely submerged in silt stood the wreck in good stead to survive a similar fate.

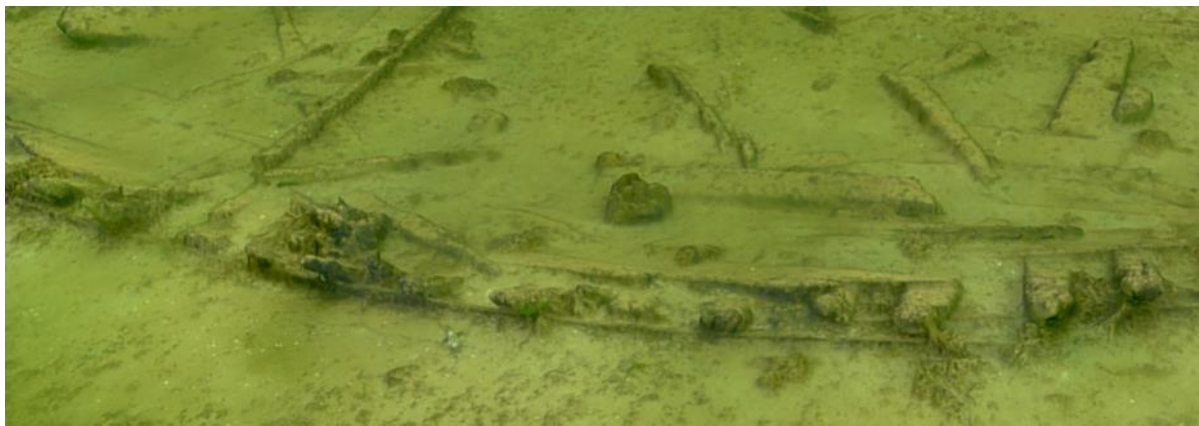
Image 5. Side and elevated view of the possible port side of the hull. Planks seem to start to overlap, but a form of double hull is evident (Same MAS.Fi weblink as above)

This could be indicative of a fully clinker style vessel. However, the turned and elevated view above seems to show a form of double hull and at the very least does not resemble the type of single hull clinker vessels characteristic of earlier or stereotypic 'Viking' vessels. It may indicate a form of technological innovation, which would make sense if this vessel were more Medieval than Iron Age. In addition, just because it may have clinker-type features in its upper frames it could still have features more characteristic of 'cog-like' vessels, which existed in the Gulf of Finland in the Medieval period, features such as a combination of clinker upper overlapping planking but edge to edge planking at a lower level. The side elevated view above, if one were to imagine the curved angle of the outer hull extending toward the keel, also gives the impression that this is not a vessel with a deep draught. All these questions can only be addressed with more exposure of the hull structure through the planned excavation.

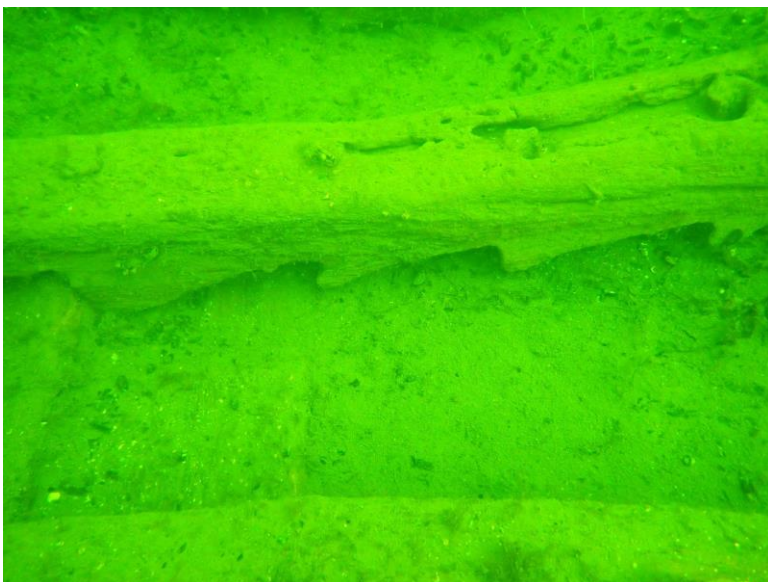
Image 11. Inner frame with clinker notches visible

The dives of the first day exposed the structure quite well on the northern side where inner frames could start to be seen attached to the inner hull where the silt had been quite shallow. However, there remained a lot deeper section of silt in the middle sections from roughly B2 to C4. A decision was made to change the strategy considering the lack of time. The central sections on just one side would be taken down deeper, so the more easterly side of the trench, only 40-50cm wide, was excavated between B2 and C4 to look specifically for the keelson, keel and mast step and larger timbers. The main priority

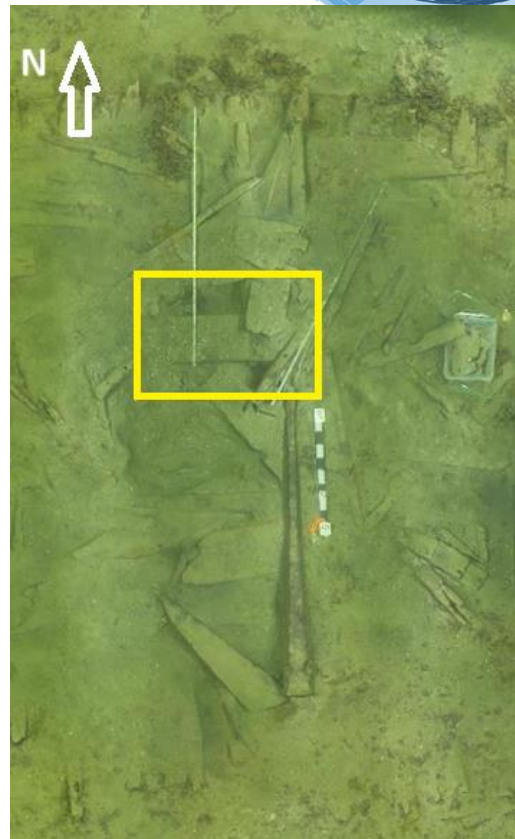
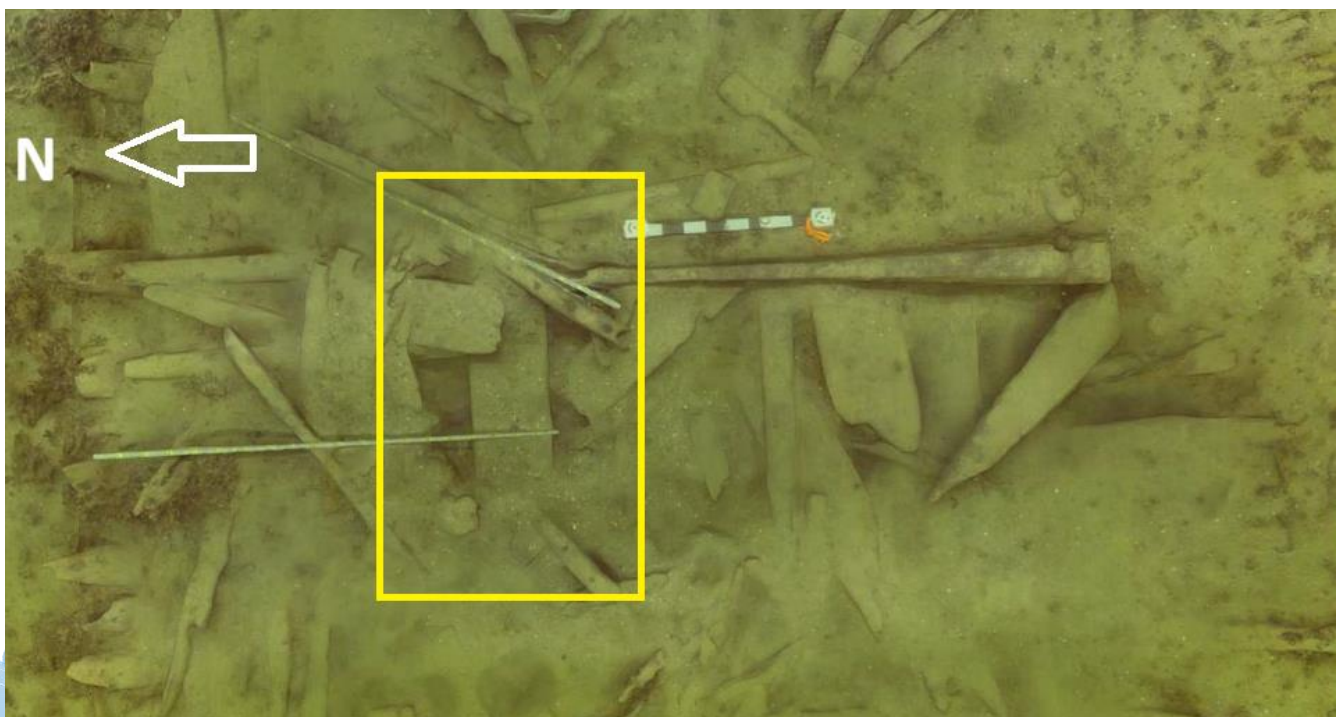
Discovery of core timbers – After changing the strategy some larger timbers began to appear in the centre of the trench on the eastern side in the grid area between C2 and C4 and very much in the centreline of the vessel. One very stout timber in the 50 cm wide trench was discovered running east to west down the centre of the vessel. It measured some 35 – 40 cm wide and over 15 - 20cm and seemed to be made of dense oak. Its position and orientation seem to indicate that this was the keelson. It was unclear how it directly related to the timbers which it sat upon, but it had no side frames connecting into it as would occur with the keel, so seemed more likely to be a keelson, sitting atop the keel. The size of the keelson indicates a stout vessel.

Images 12 (right). Photogrammetric image of the trench lying north to south, with horizontal keelson highlighted.
Full 3D-model link at the end of the report.

Image 13 (below). Magnification of excavated trench

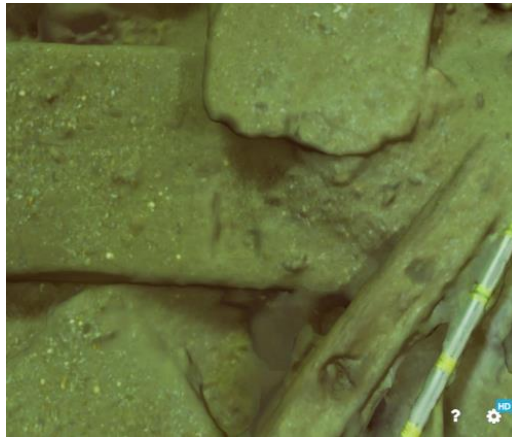
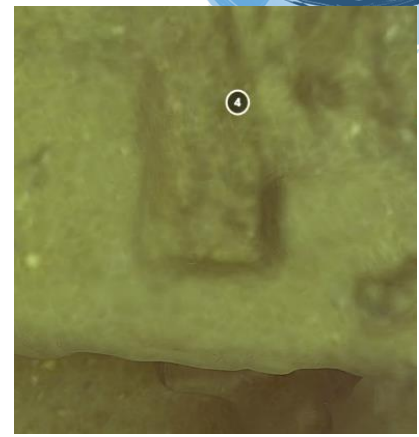
Images 16 & 17: Possible mast step

A possible mast shoe was partially visible and undamaged, extending into the keelson. It shows a slot that could provide support for a timber, the base of a possible mast or for another timber. Viewing the photogrammetric image almost suggests the squarish slot is the bottom edge of a larger, perhaps even cross-shaped slot, which is hidden under the timber coming from the north side (star-board). A possible lateral support, typical of cogs, was discovered at the possible mast

shoe (see images 16 & 17). The shape and size of the slot could give functional and stylistic insight into the construction techniques used in the vessel but was only partially visible at this point. It was left alone with no time then to investigate further, combined with a desire to protect it for the moment, until MAS.Fi gets the opportunity to excavate further.

The mast step will be carefully unearthed and examined. The trench will be more intensively excavated with the aim to fully interpret the central hull structure, both vertically through whatever decks it may or may not have, but also then be able to look horizontally towards the stern and bow within the vessel's structure. A combination of accurate dating, a sense of its provenance gained from the next dendro samples, and an understanding of the construction details of the vessel, would have the potential to provide much more meaningful insight into its place in nautical technological development models and the maritime history of both the Gulf of Finland and perhaps the wider Baltic.

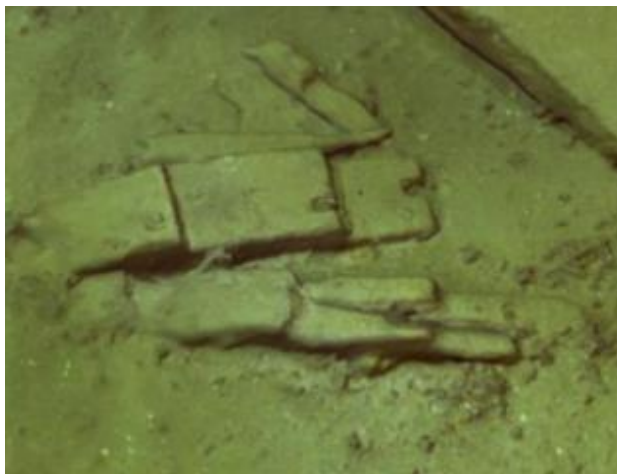
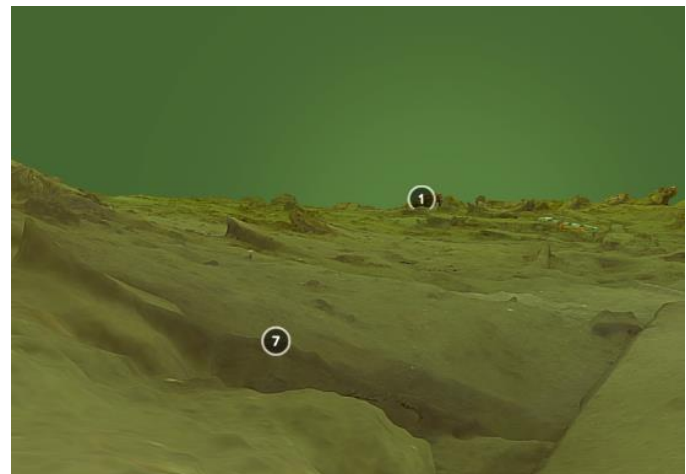
Other features – Several timbers were seen that had clinker features. The first image below shows what looks to be loose interior clinker-shaped supportive frames that would have slotted into planks in the inner surface of the rising hull. The second shows probable outer clinker-style planking on the southern portside frames partially submerged into the silt.

Image 18 & 19. Clinker-shaped frames and outer planking

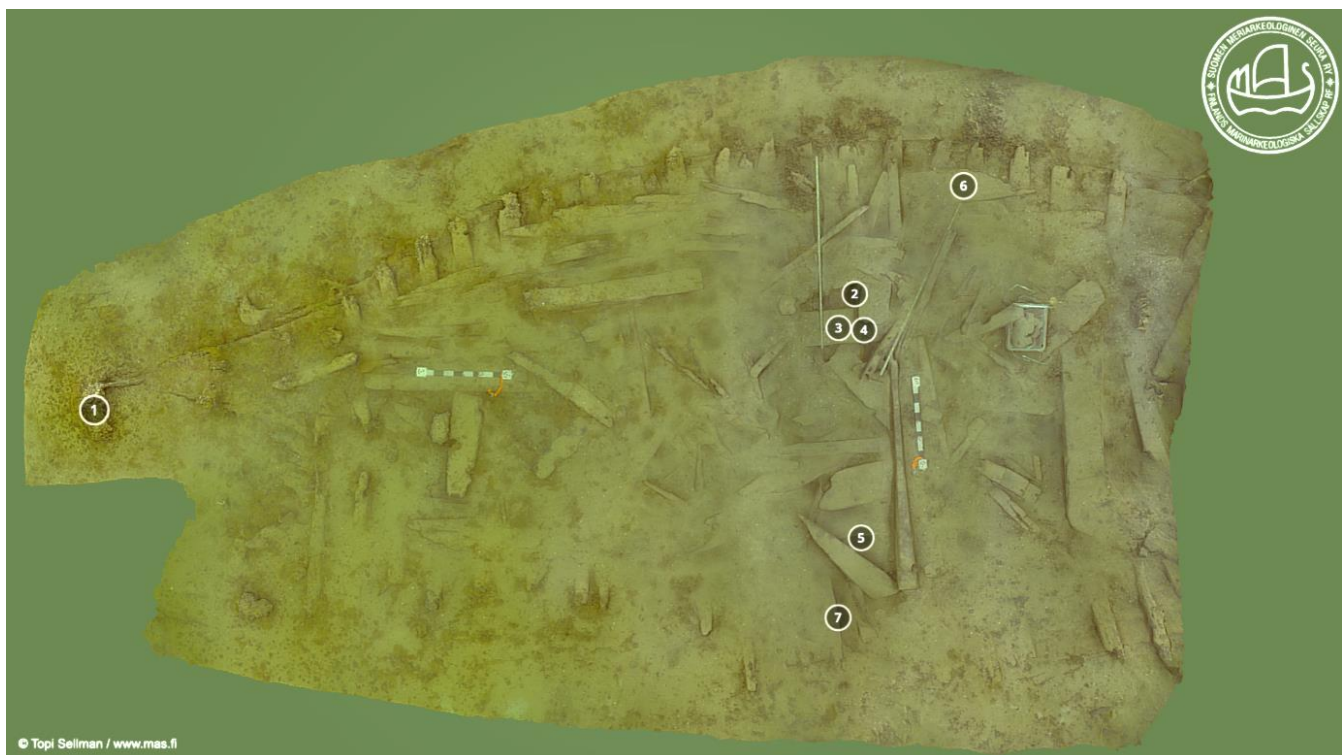
Image 20: "Aerial view" image from the 3D model of the wrecksite

Notes – 1. Sternpost broken 2023-2024

2. 'Björnar' i.e. mast step supports

3. Keelson

4. Mast step?

5. Clinker-build timber?

6. A deck level

7. Stepped-looking frames
