Hearth Wreck - Uunihylky (Kirkkonummi) MVID#1183

The "Hearth Wreck" appears to have been about 32 meters long, a carvel-built sailing ship made of oak, which sank somewhere in the 1630's or -40's. The vessel is most likely one of the Swedish Navy ships, either a lightly armed warship or a yacht.

Syvyys & pituus & suunta: Depth 8-9m, length 32m jand Keel line about 320°/140°

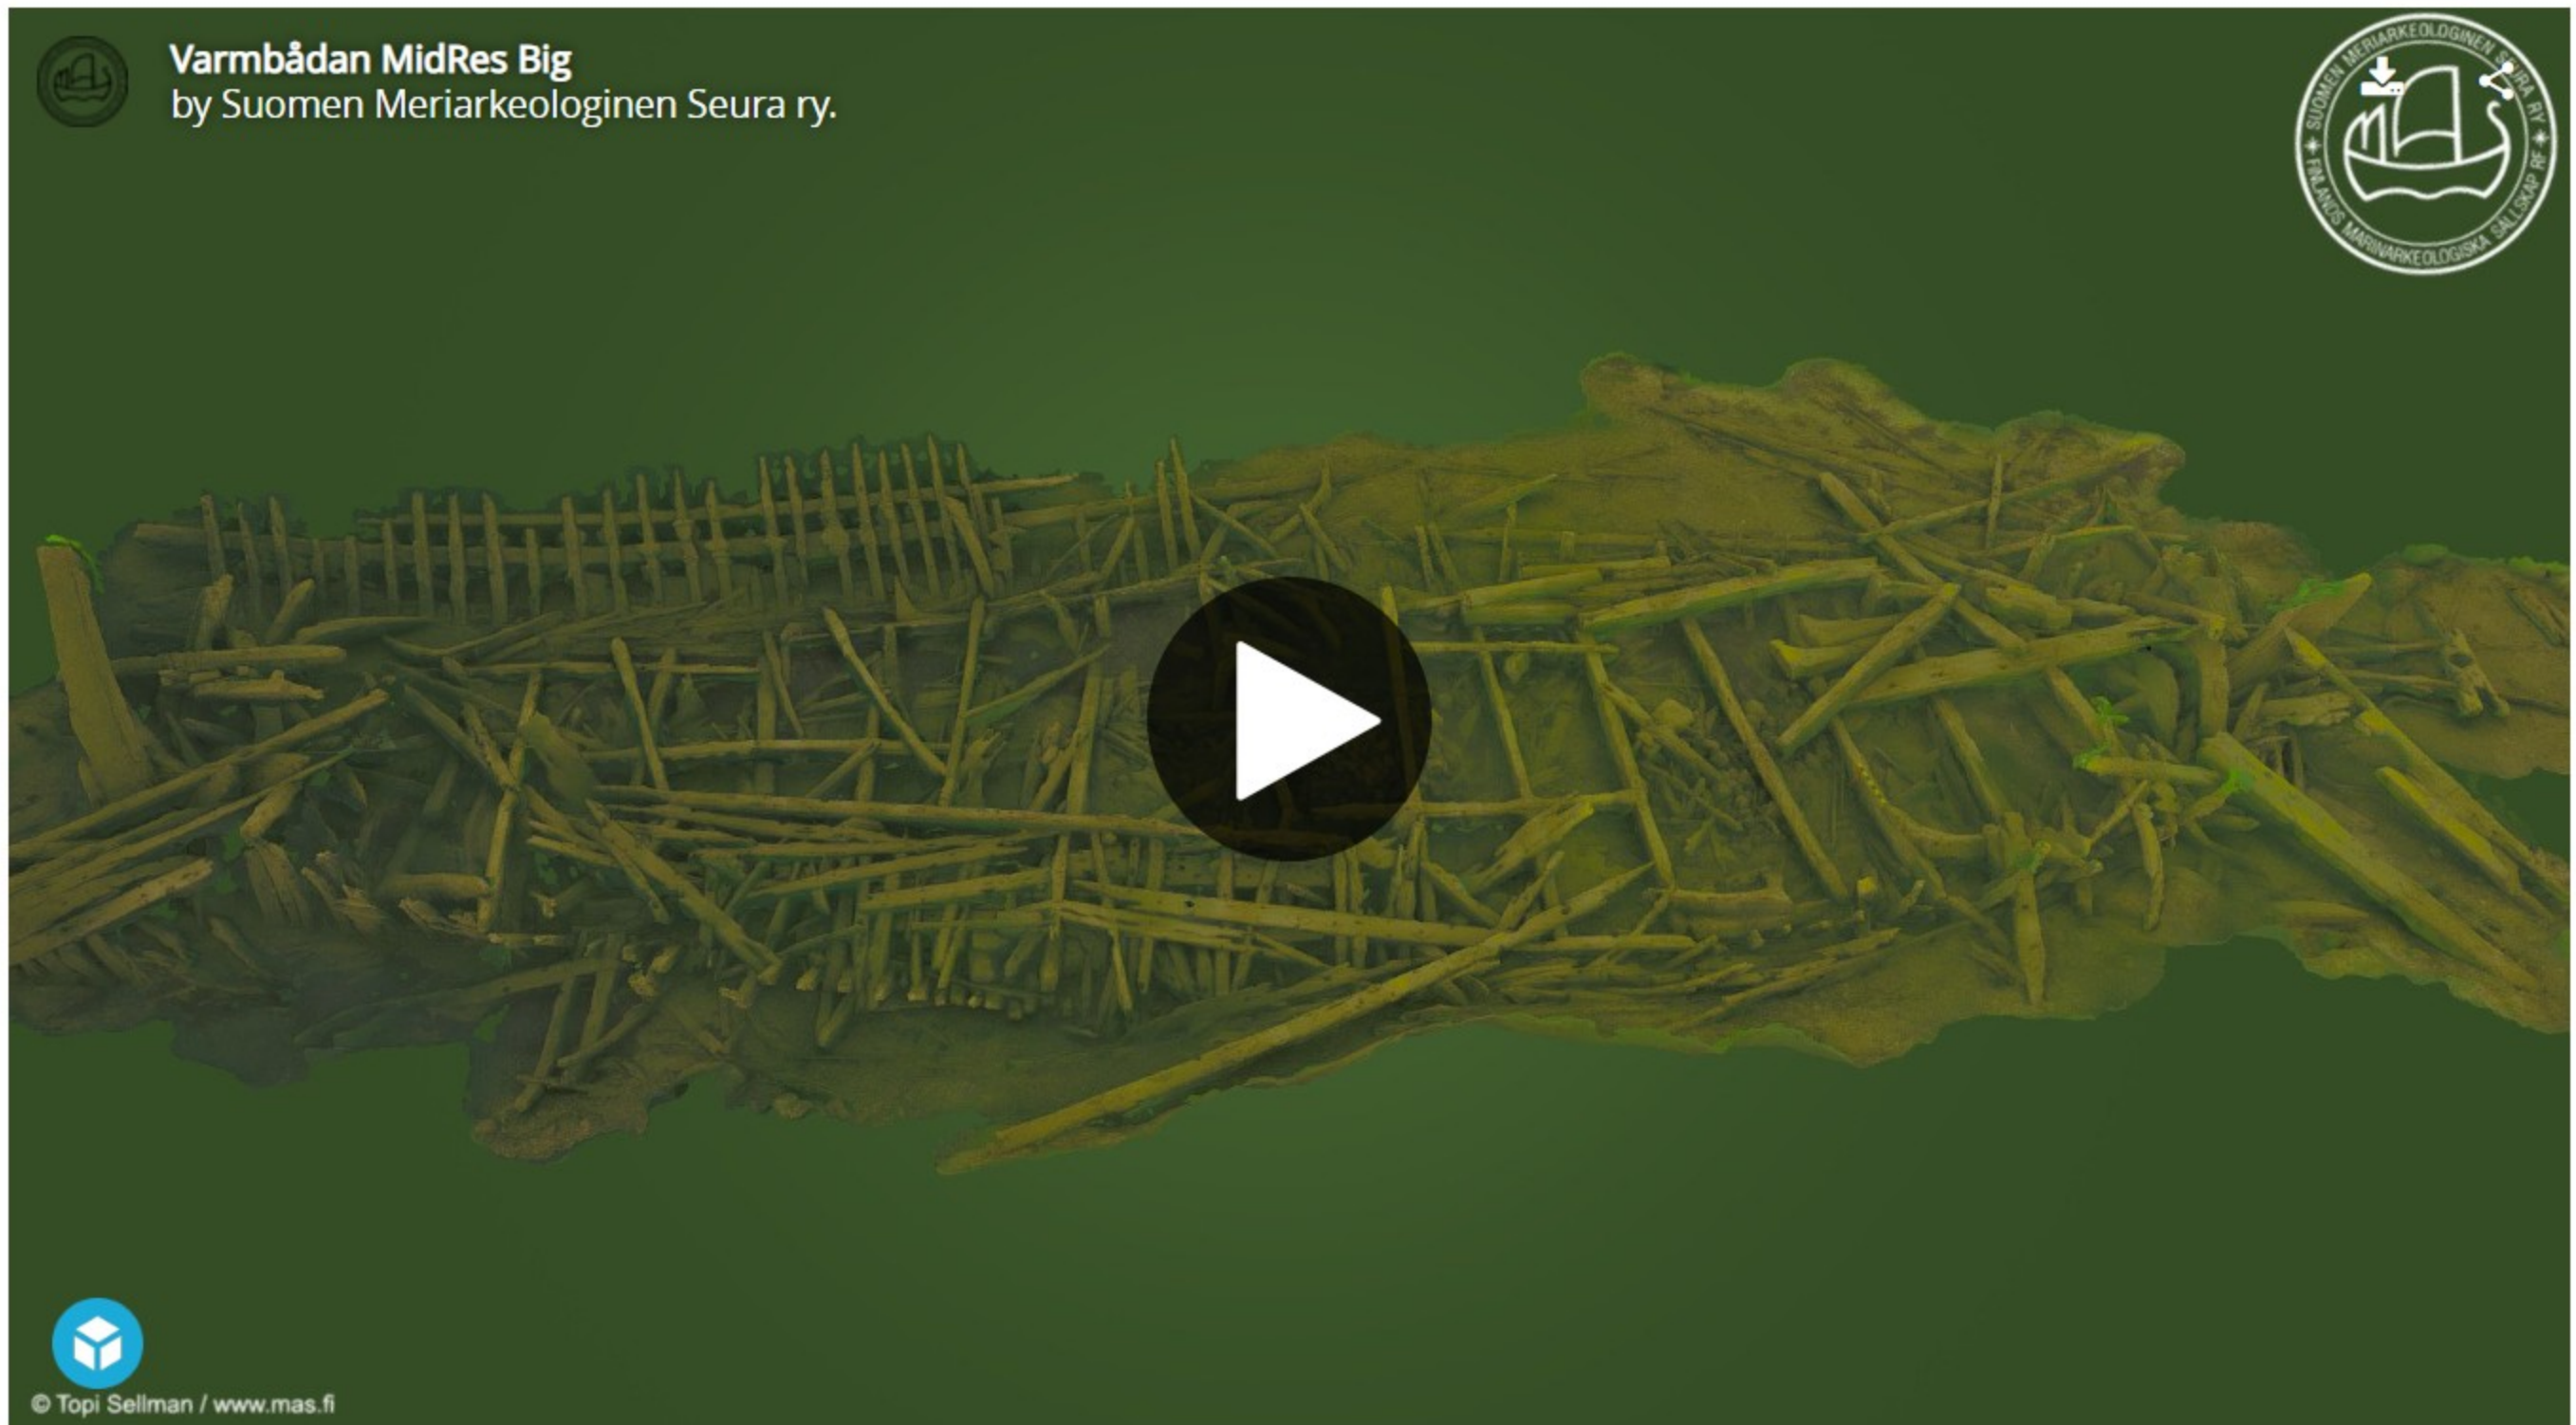
Annotated 3D-Model of the Hearth Wreck as of July 2021

Varmbådan MidRes Big by Suomen Meriarkeologinen Seura ry. on Sketchfab

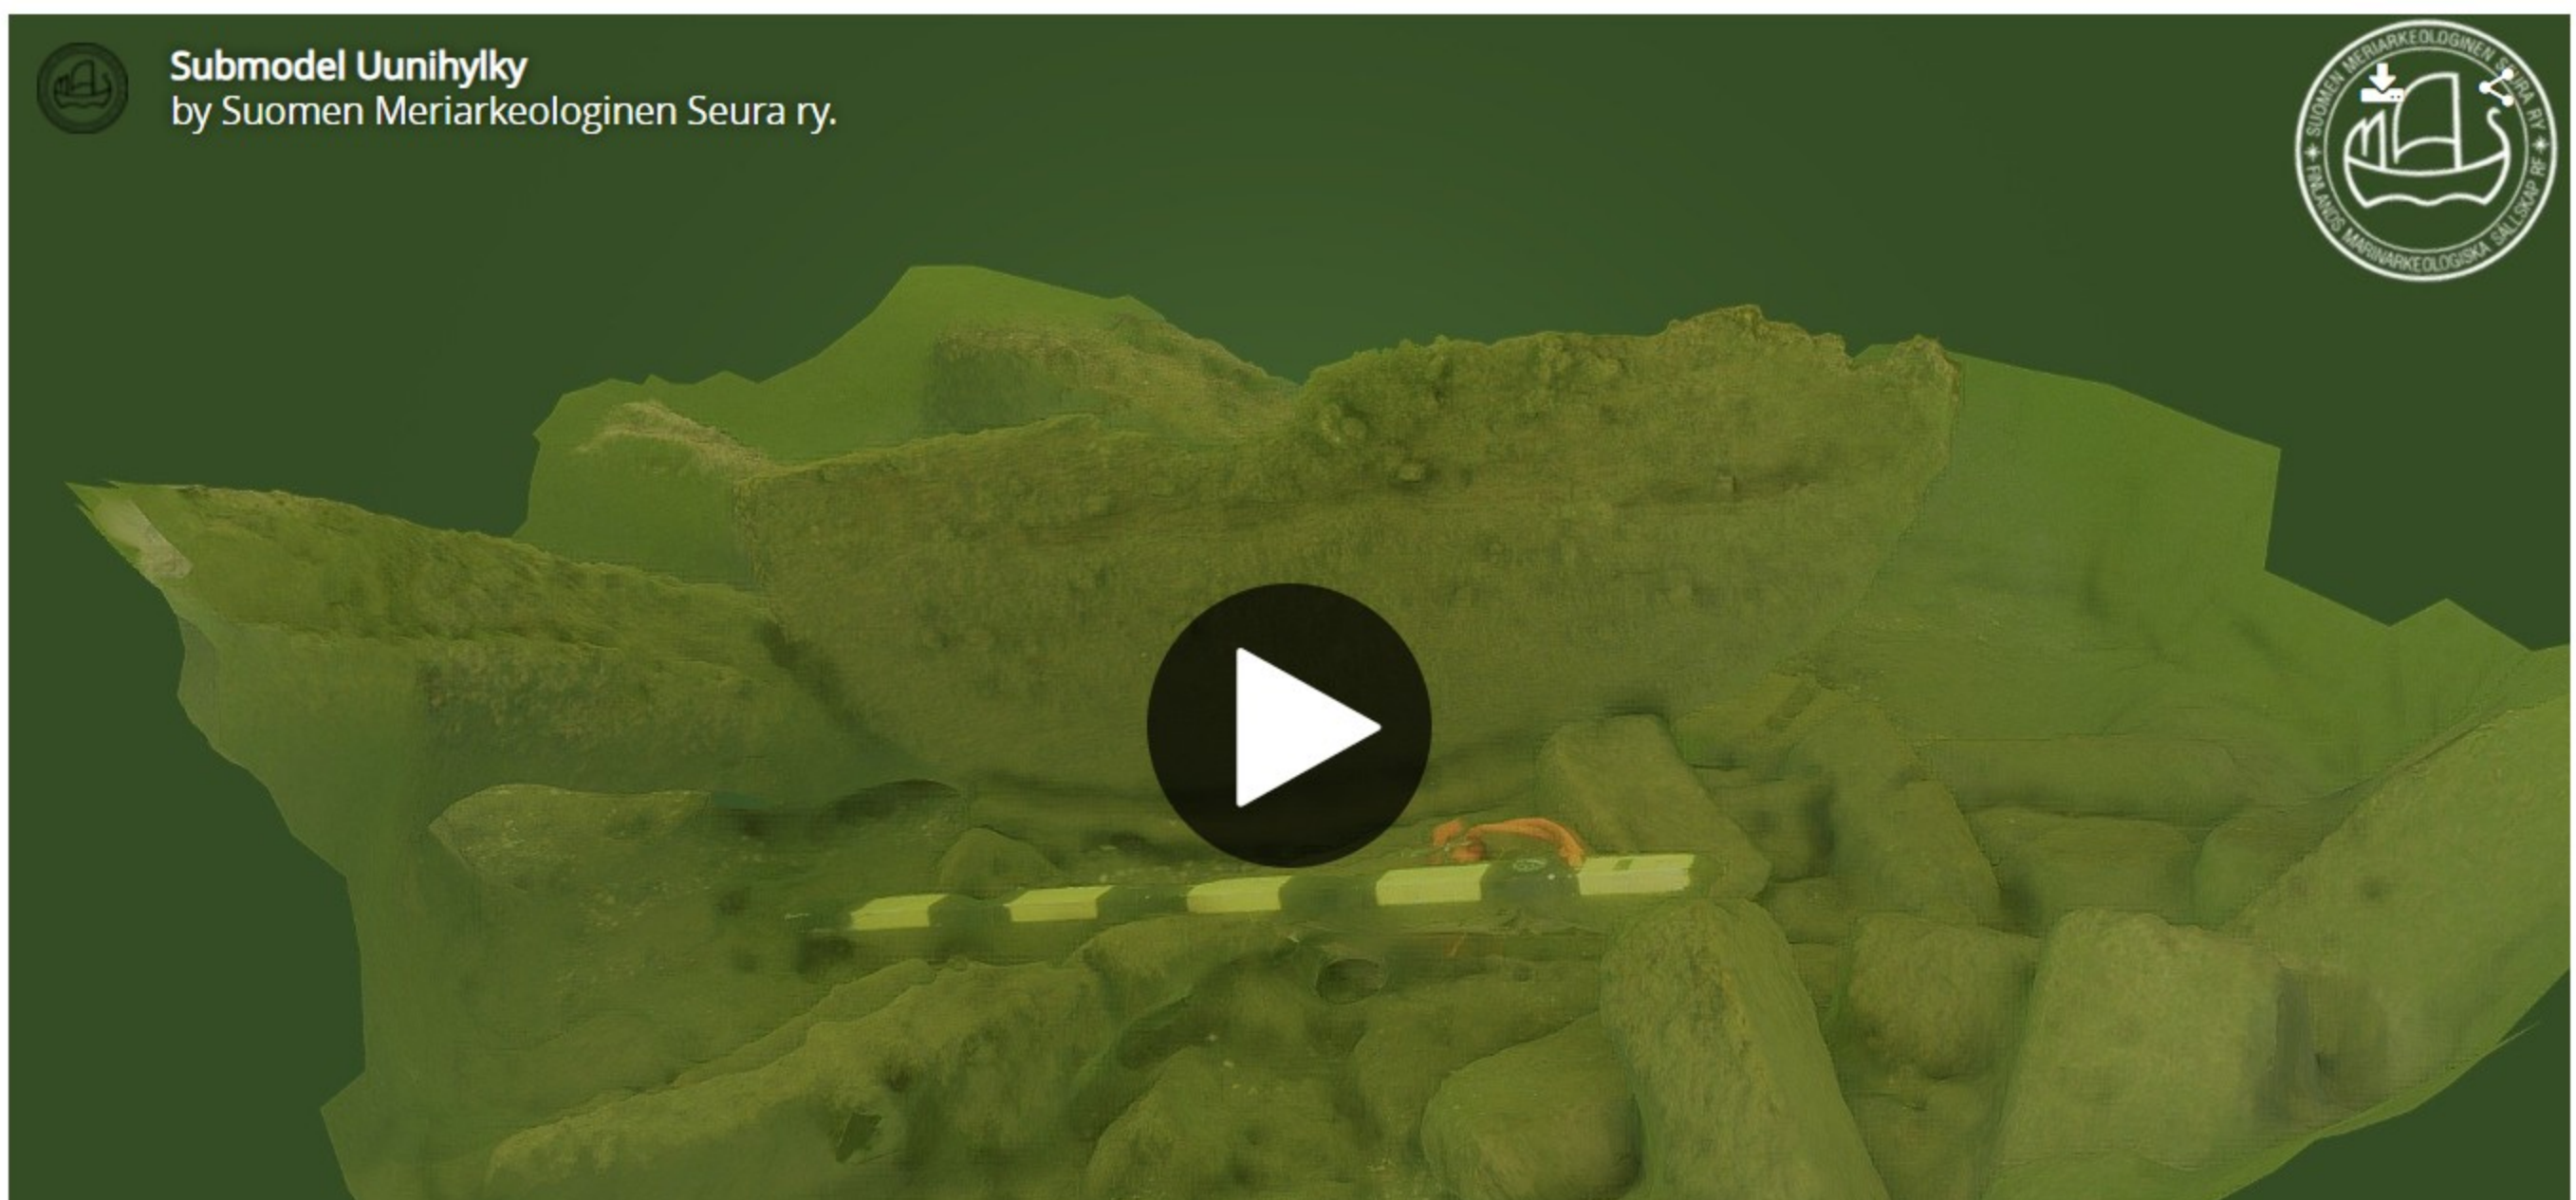
Sub-Model of the "Bading Barrel" in Hearth Wreck as of July 2022

Submodel Uunihylky by Suomen Meriarkeologinen Seura ry. on Sketchfab

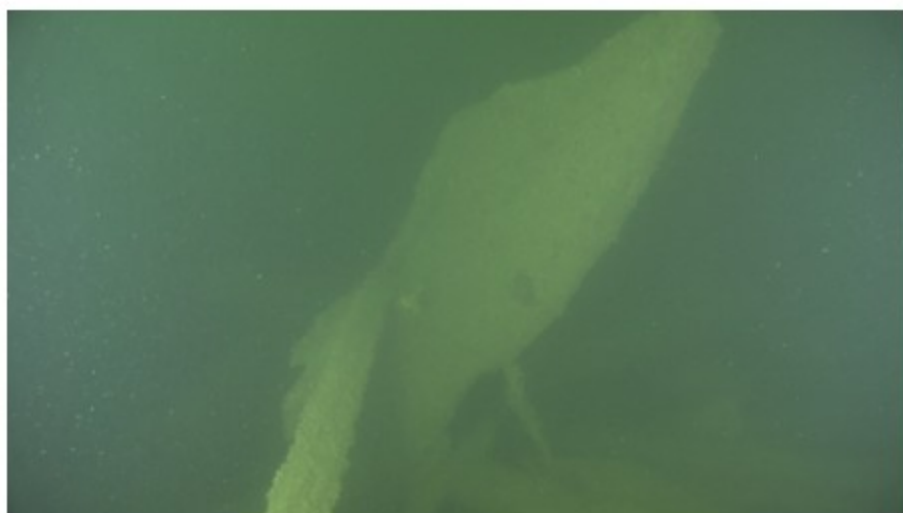
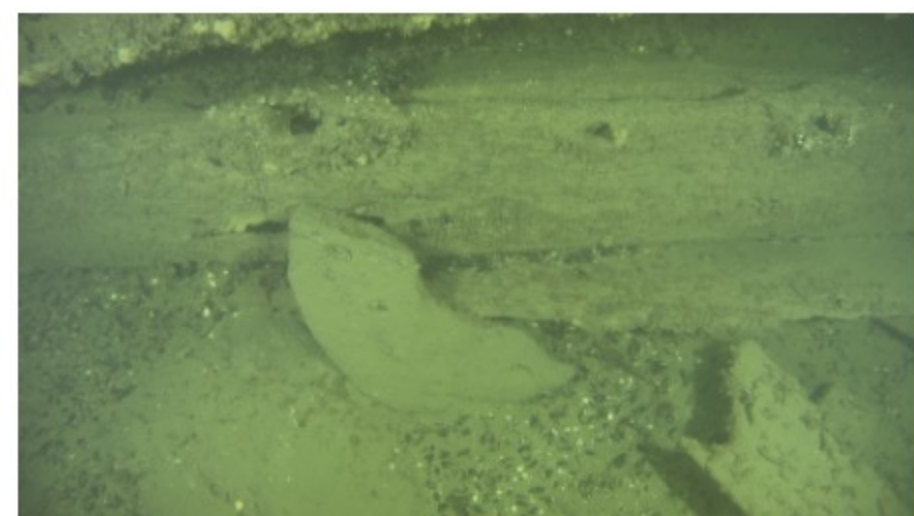
The hearth from the port side

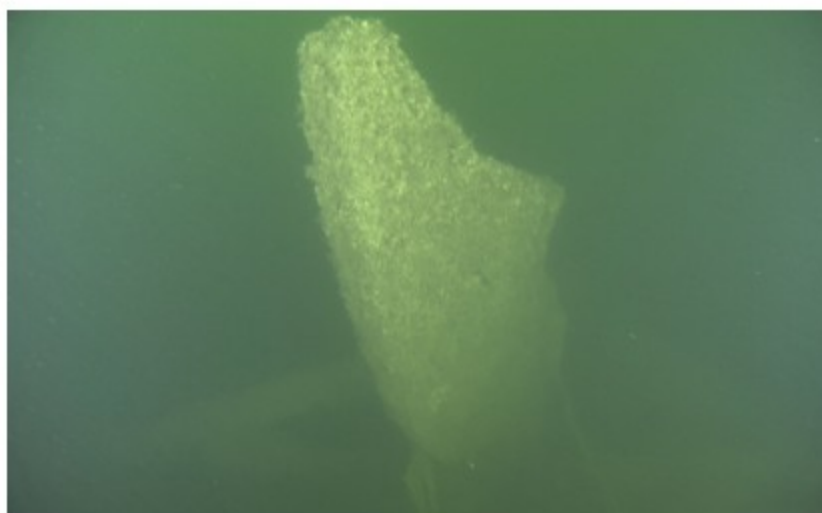
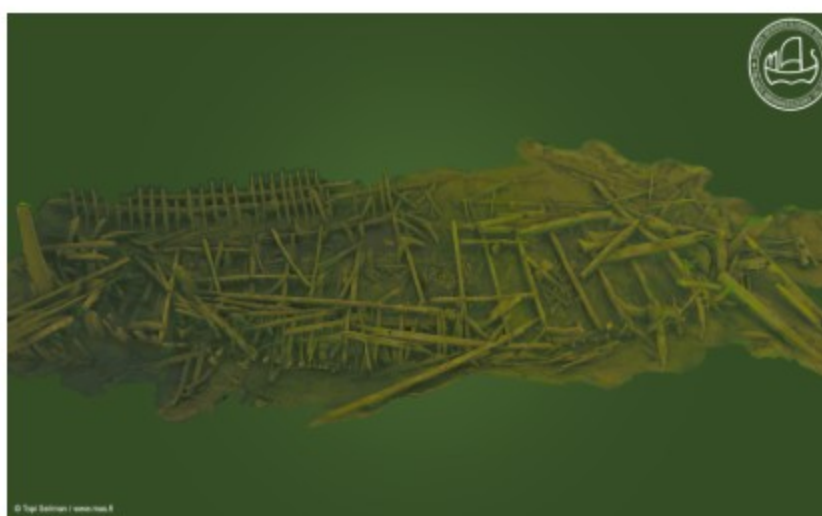
A gunport on the port side

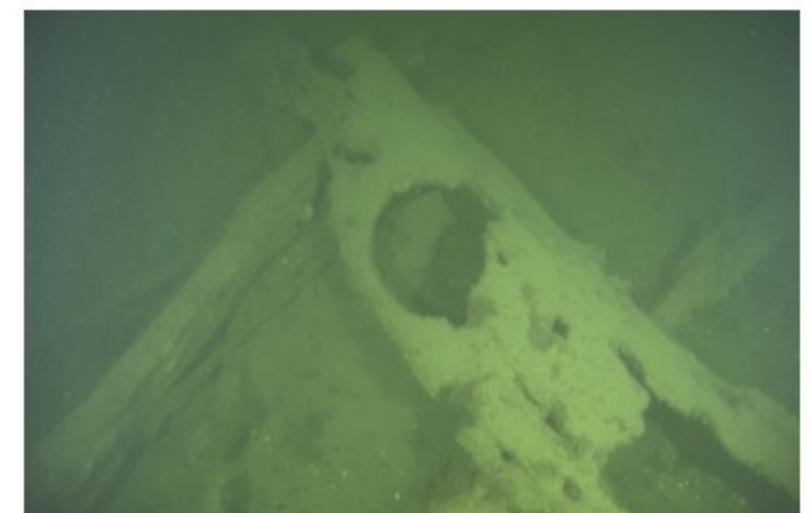
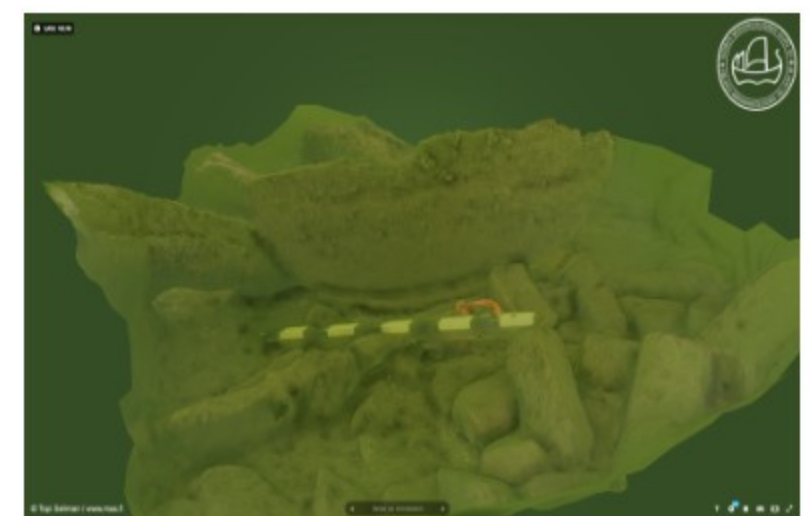
A close up from the gunport framing

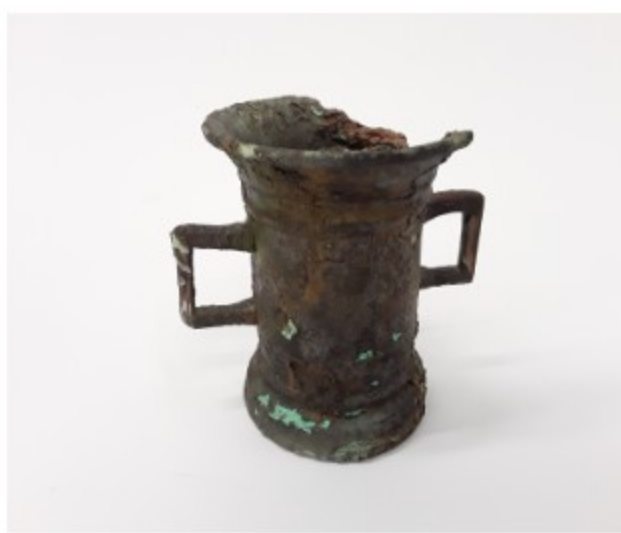
SMM981:1

A cylindrical pewter tankard with a wide base ring, featuring two rectangular handles in the middle of the sides. After the handles, the upper edge of the tankard flares gently.

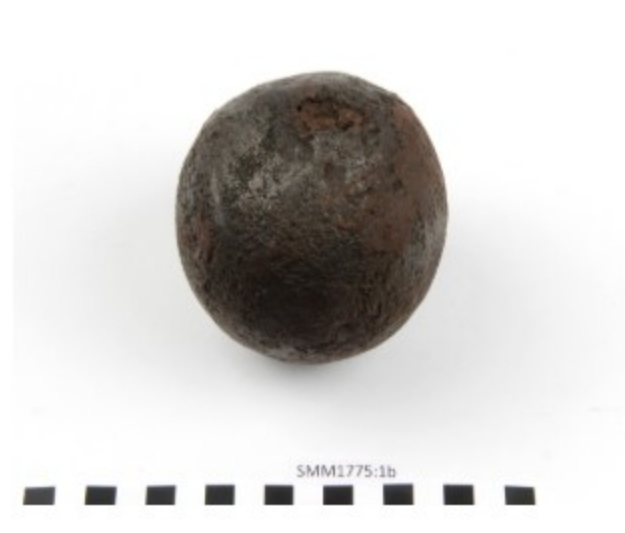
SMM1775:1b

An iron cannonball. Corroded. Light for its size.

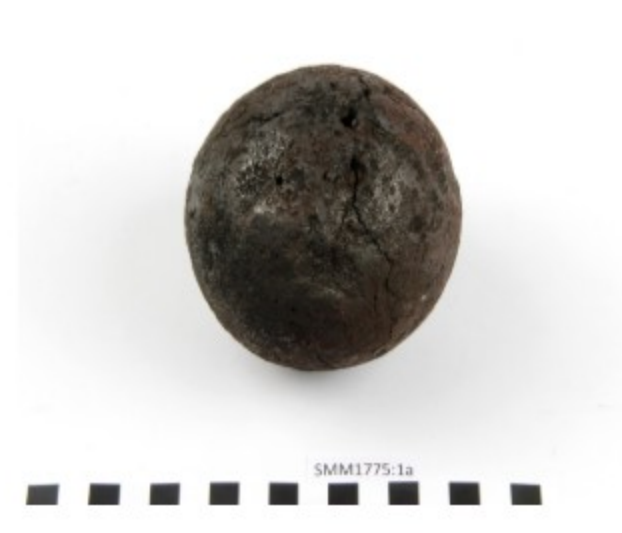
SMM1775:1a

An iron cannonball. Corroded, slightly cracked. Light for its size.

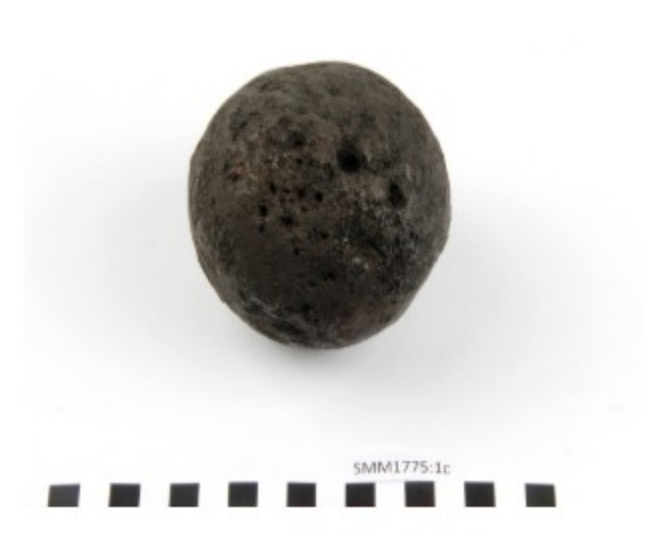
SMM1775:1c

An iron cannonball. Corroded and deformed. Light for its size.

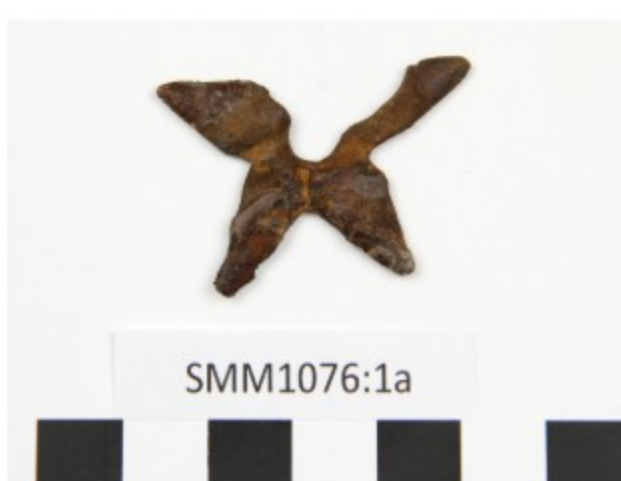
SMM1076:1a

A part of a brass star-shaped spur. Originally a five-pointed star with a round hole in the center; now one point is missing.

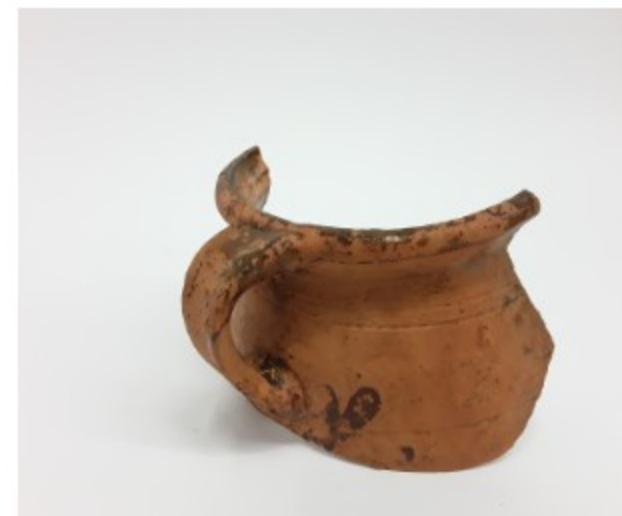
SMM277-1

A piece of a pot made of red clay. The fragment is from a pot glazed greenish-brown on the inside. The pot had a rounded body with a narrower neck featuring decorative grooves. The neck flares slightly towards the rim of the pot. A curved handle extends from the rim, with two indentations at its base.

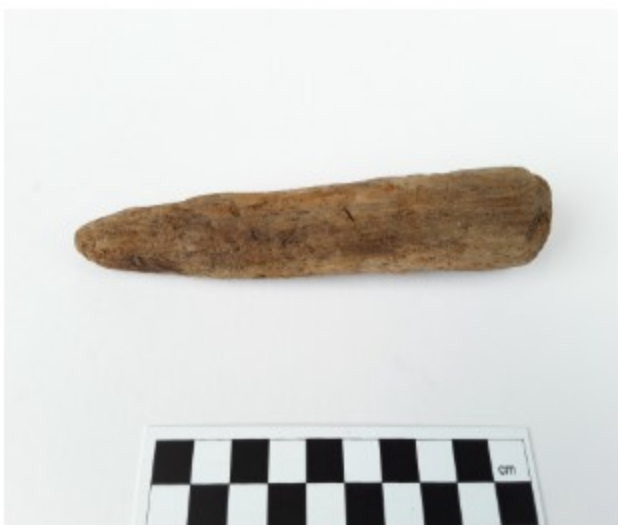
SMM302006_4

A conical, sharp-pointed rod. Fairly sturdy. Possibly contains iron corrosion products inside.

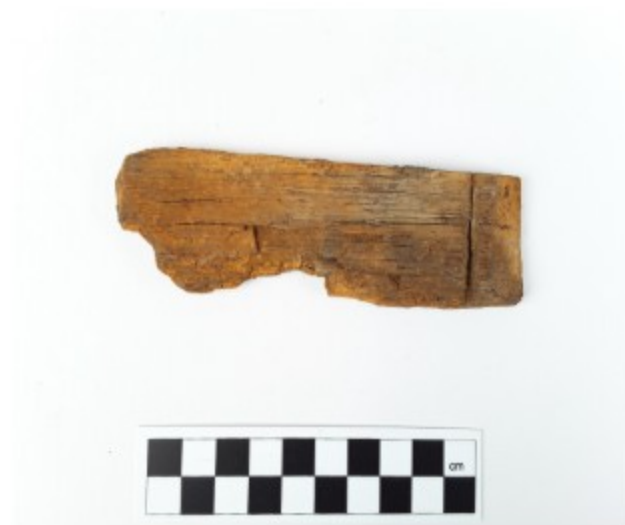
SMM302006_7

A stave that is damaged at its wider end. The other end is beveled and has a carved groove.

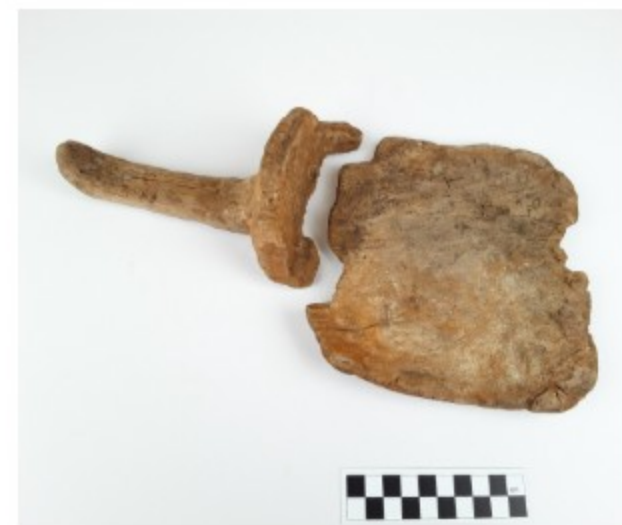
SMM302006_6a-b

6a: A square piece with many small cracks and tiny holes on its surface (possibly caused by pests?). The piece is very soft.
6b: A wooden vessel handle with a small part of the vessel still attached. The thinner end of the handle bends slightly downward. The object is soft and has many small cracks on its surface.

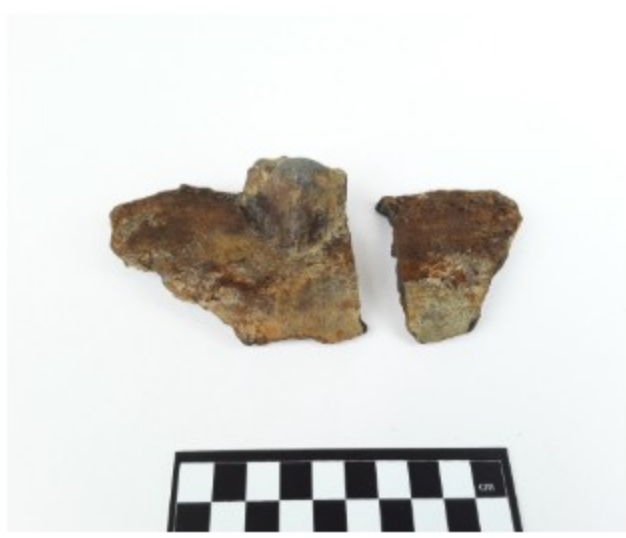
SMM302006_12a-b

Fragments of a pot or similar ceramic item, with a larger piece featuring a triangular protrusion. The pieces fit together.

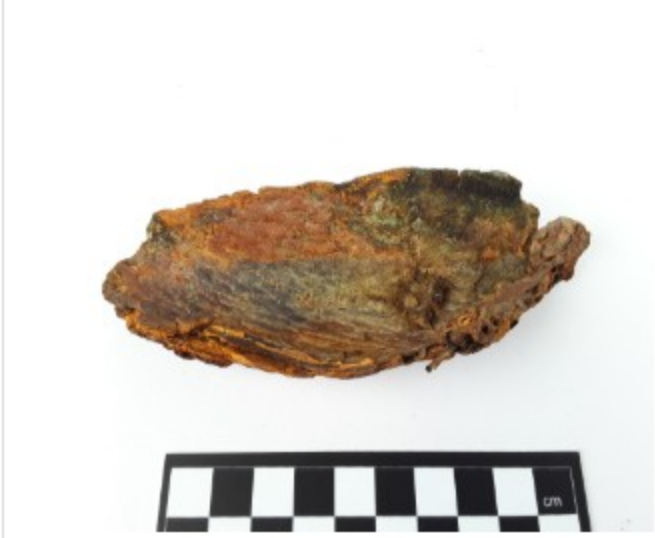
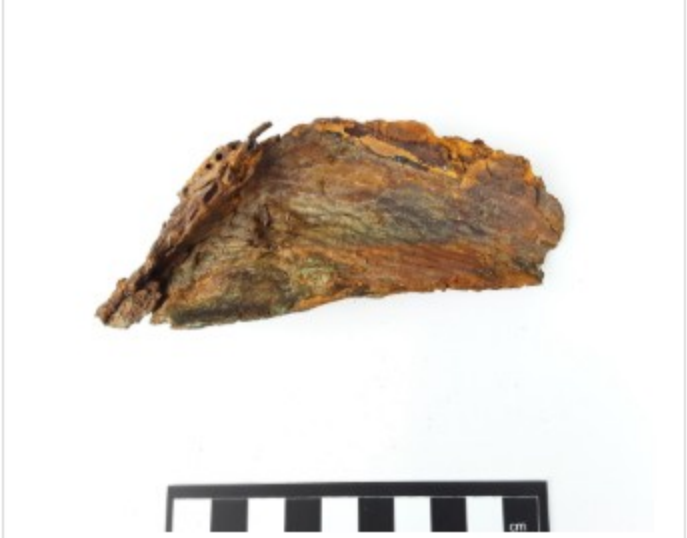
SMM302006_13

An elongated, ear-shaped piece of leather with a yellowish formation on top. The thickness varies somewhat, and it appears that the object has a layered structure.

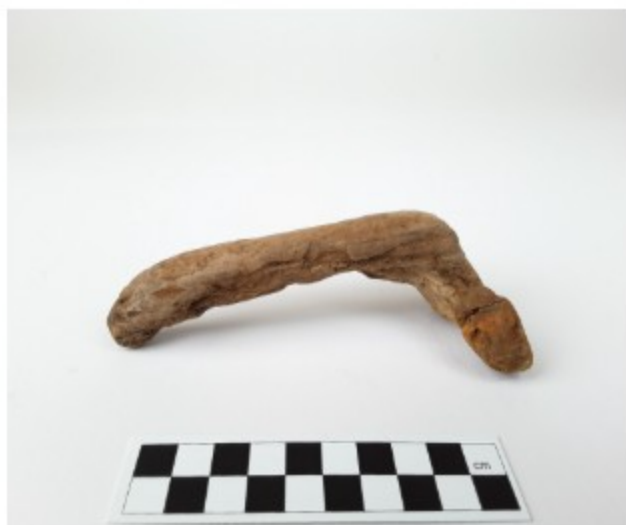
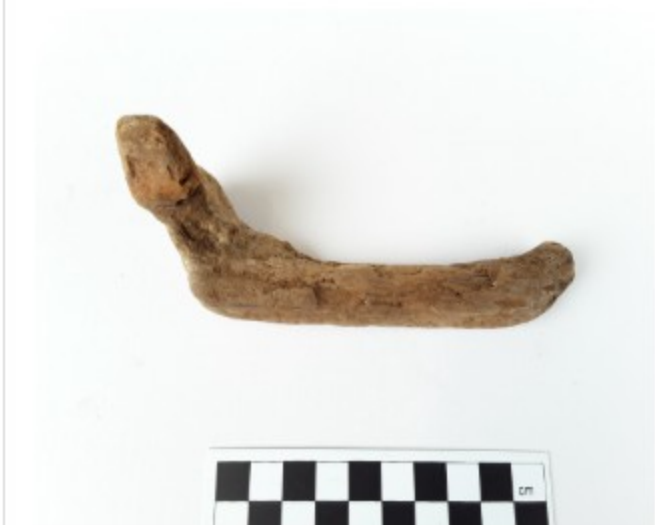
SMM302006_3

A piece with a relatively intact "handle." The wider end has remnants of the vessel part, and the outer, narrower end bends downward.

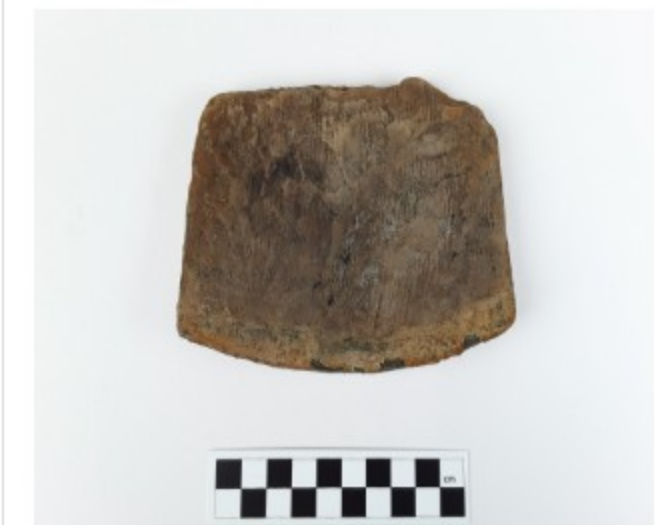
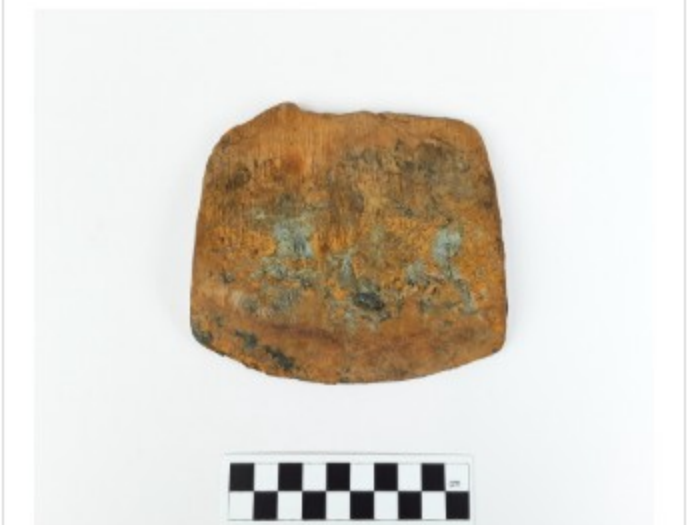
SMM302006_5

A piece shaped like an axe blade, possibly a stave. One end is beveled to a blade-like edge. The object feels heavy and shows signs of iron corrosion products on its surface.

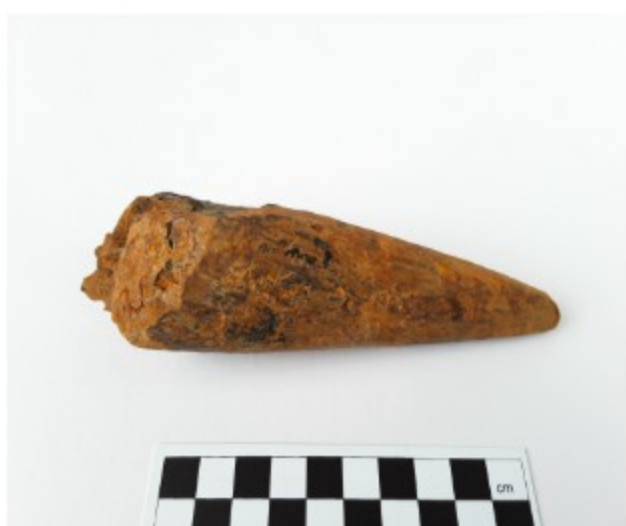
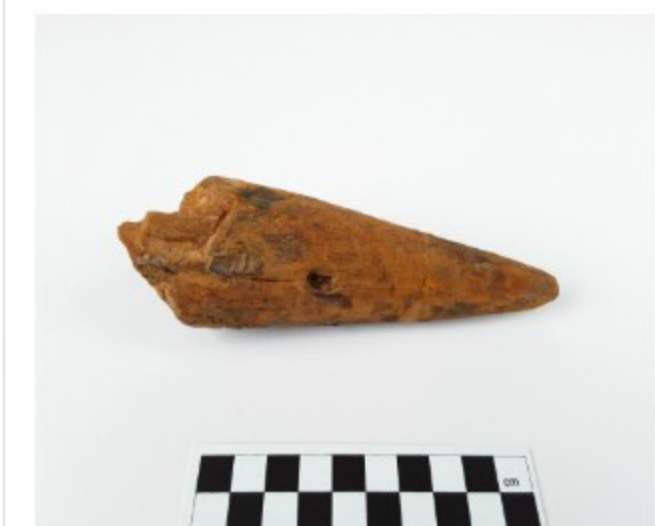
SMM302006_1

A conical object carved to a sharp point, clearly broken at the wider end. The surface shows some signs of iron corrosion products.

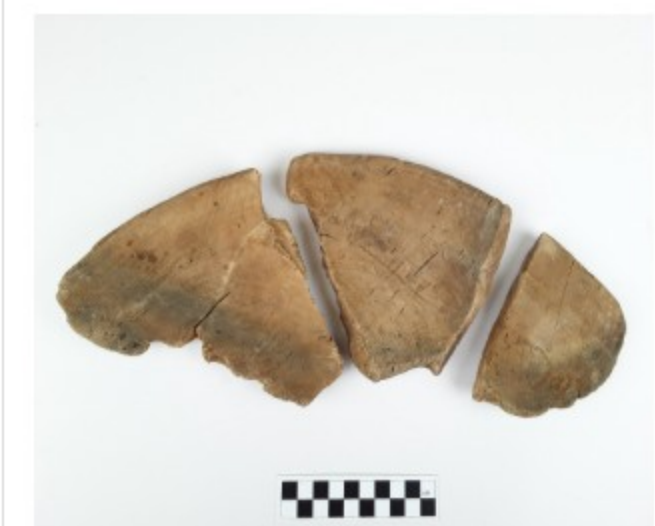
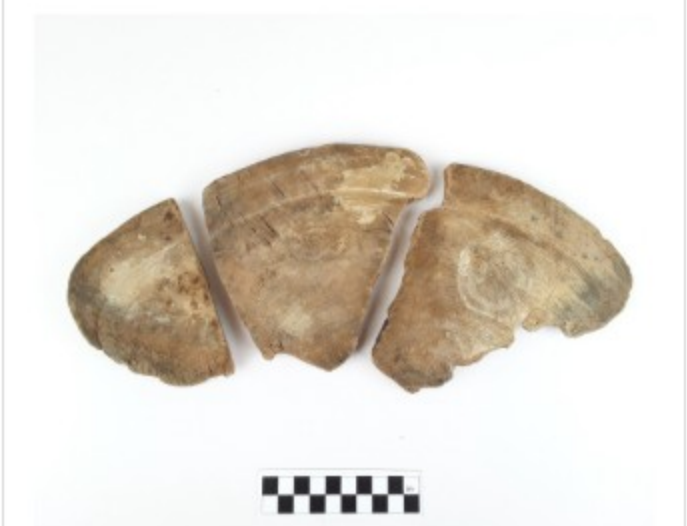
SMM302006_2a-c

Matching wooden pieces that are apparently part of a bowl or plate. One side of the object is very smooth and shaped like a plate.
