Excavation Report Hamnholmarna (MVID#1516)

Maritime Archaeological Society of Finland report against Finnish Heritage Agency's research permit **MV/01110/2024** regarding the Kemiönsaari, Hamnholmarna (MVID#1516) intrusive test excavation.

Hamnholmarna (MVID#1516) Excavation Report

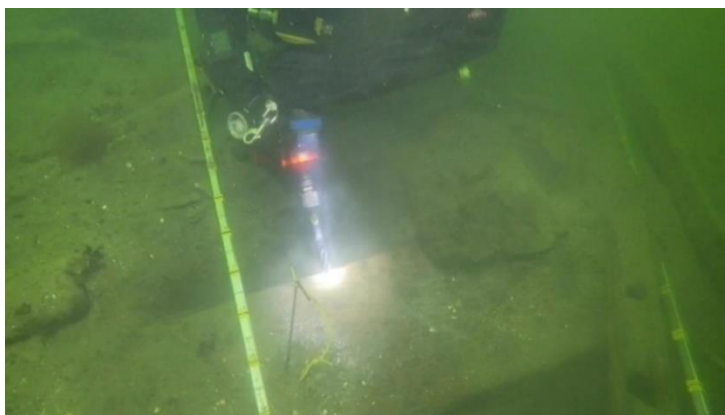
Image 14. Taking the first dendro sample with the drill

In line with the project core aims the dendrochronology drill invented by MAS.Fi was used to take 3 samples from this timber. This underwater drill is powered by battery and uses a hollow drill bit to penetrate the dense wood. The drill is usually installed into a stout rig which is screwed into the timber to make sure the drill bit does not oscillate and therefore get caught. Unfortunately, the first sample (its position shown in the photograph below as directed in the permission statement) was taken using a hand grip of the drill and the bit became caught. This was an unfortunate yet a valuable lesson, particularly when dealing with dense timber. The next 2 employed the full rig. The specimens were transferred to plastic tubes and stored on board in the fridge. They sadly seem to contain very few rings and a large amount of mush. The specimens are at present being sent off to the laboratory for C14 analysis.

The 'dendro drill' was employed as historically it has caused less damage to the timber and produced specimens within sometimes 10 minutes. However, it is worth considering that if the drill proves to be largely ineffective against some dense timbers, even when the rig is firmly attached, and the dating of the timbers is a crucial part of the project, having gone through so much preparation, funding and effort to get there, then the team should bring along a saw, or better underwater chainsaw, to make sure a specimen is achieved that is more likely to produce rings.
